# Manhole Inspection Summary

Manhole # S250\_\_006MH

Insp Date: **4/2/08 11:25 AM**

**Location** Address: **1402 Carrol St**

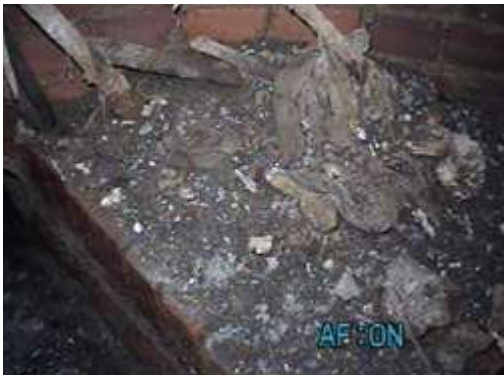
Defect 5

Condition: ☐ Sound ☐ Cracked ☐ Root Intrusion ☐ Deteriorated ☐ Leaks ☒ **Debris**

Bench Debris

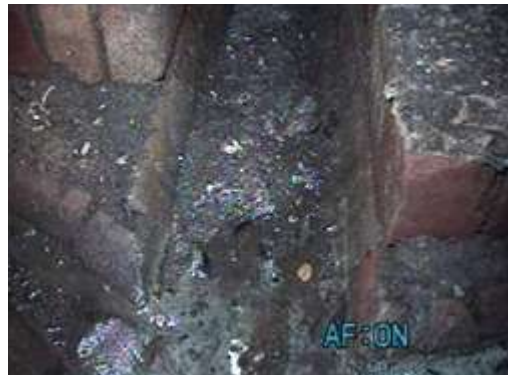
Defect 1

Condition: ☐ Sound ☐ Cracked ☐ Root Intrusion ☐ Deteriorated ☐ Leaks ☒ **Debris**

Channel Debris

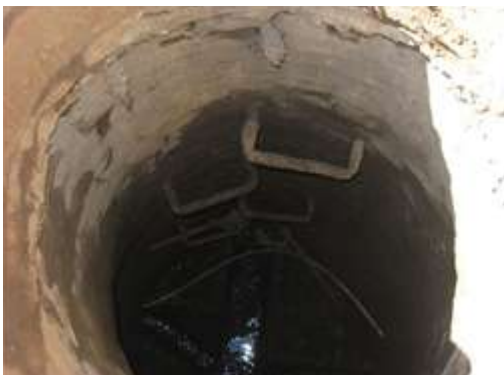
Defect 3

Count: **5** Missing: **1** ☒ **Corroded**

Corroded steps

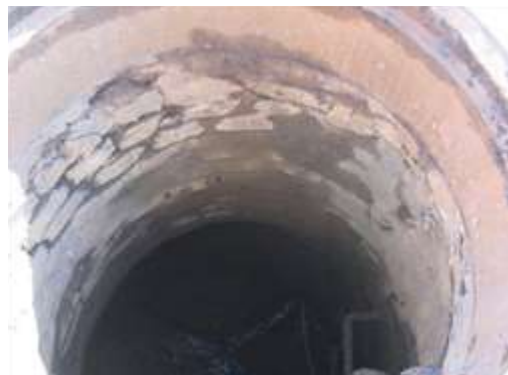
Defect 4

Condition: ☐ Sound ☒ **Cracked** ☐ Root Intrusion ☐ Loose Brick ☐ Deteriorated

Infiltration: ☐ None ☐ Joint ☐ Cracks ☒ **Mortar** ☐ Roots ☒ **Wall**

Corbel Crack and Infiltration,

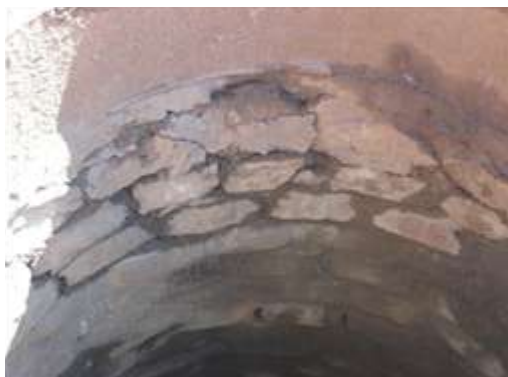
## Defect 2

Condition: ☐ Sound ☒ **Cracked** ☐ Root Intrusion ☒ **Loose Brick** ☒ **Deteriorated**

Infiltration: ☐ None ☒ **Joint** ☐ Cracks ☐ Mortar ☐ Roots ☒ **Wall**

Cracks, Loose Bricks and Deteriorating Chimney, CHimney Infiltration

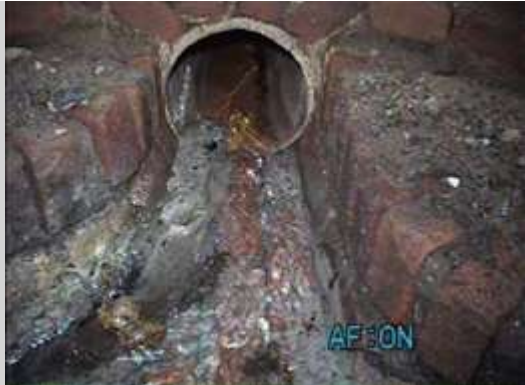
12 O'Clock Outflow

sediment in channel

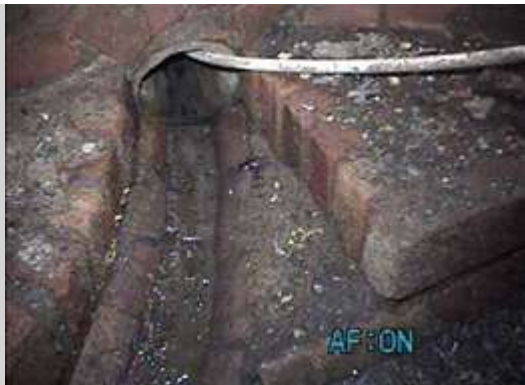
4 O'Clock Inflow

Sediment in channel

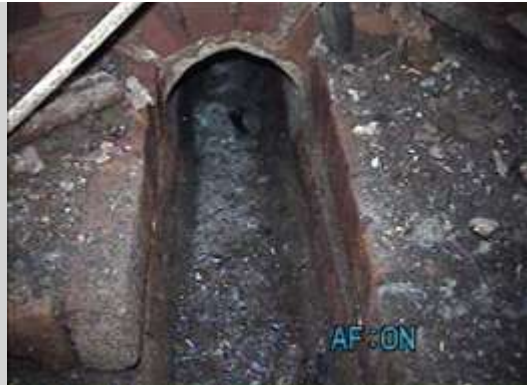
6 O'Clock Inflow

sediment in channel

Silt Depth: **0** (in.) Deposits Extent: **Light**
